Ivor Wildin
Director, WTS

API 653: TANK INSPECTION CODE: TANK LIFTING AS AN OPTION TO REPAIR

**FLOOR CHANGE
AUSTRALIAN LUBRICATION MANUFACTURERS
FREMANTLE, WESTERN AUSTRALIA
A JOINT CALTEX/BP FACILITY**

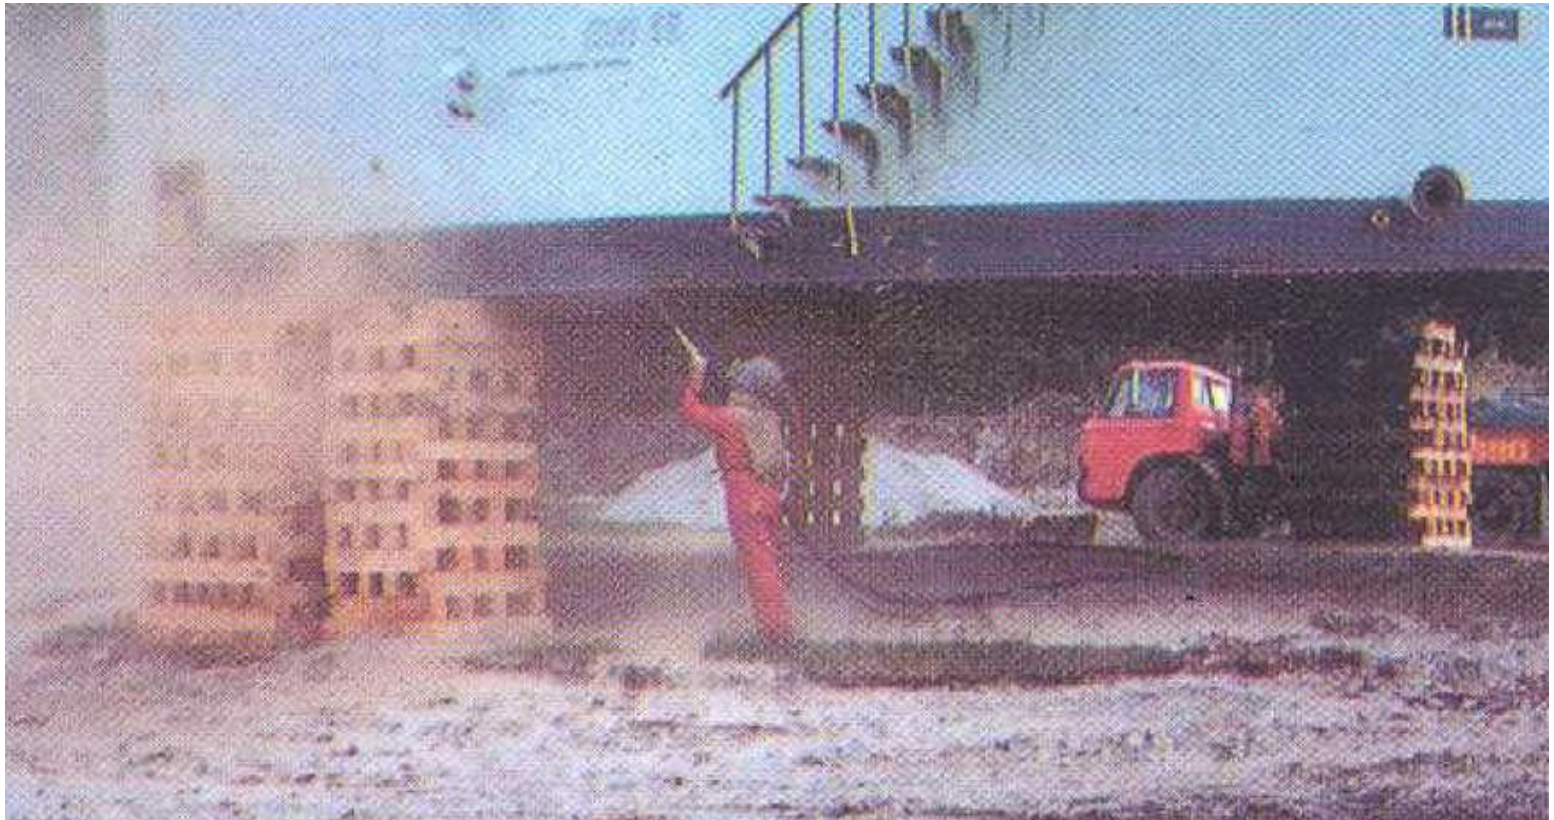
This tank had leaked twice at SRC Singapore and the floor was to be replaced. After lifting it was found that the MFL Scan was in error and there was only two holes in the floor due to stones the rest of the floor had the heat numbers still visible in perfect condition!

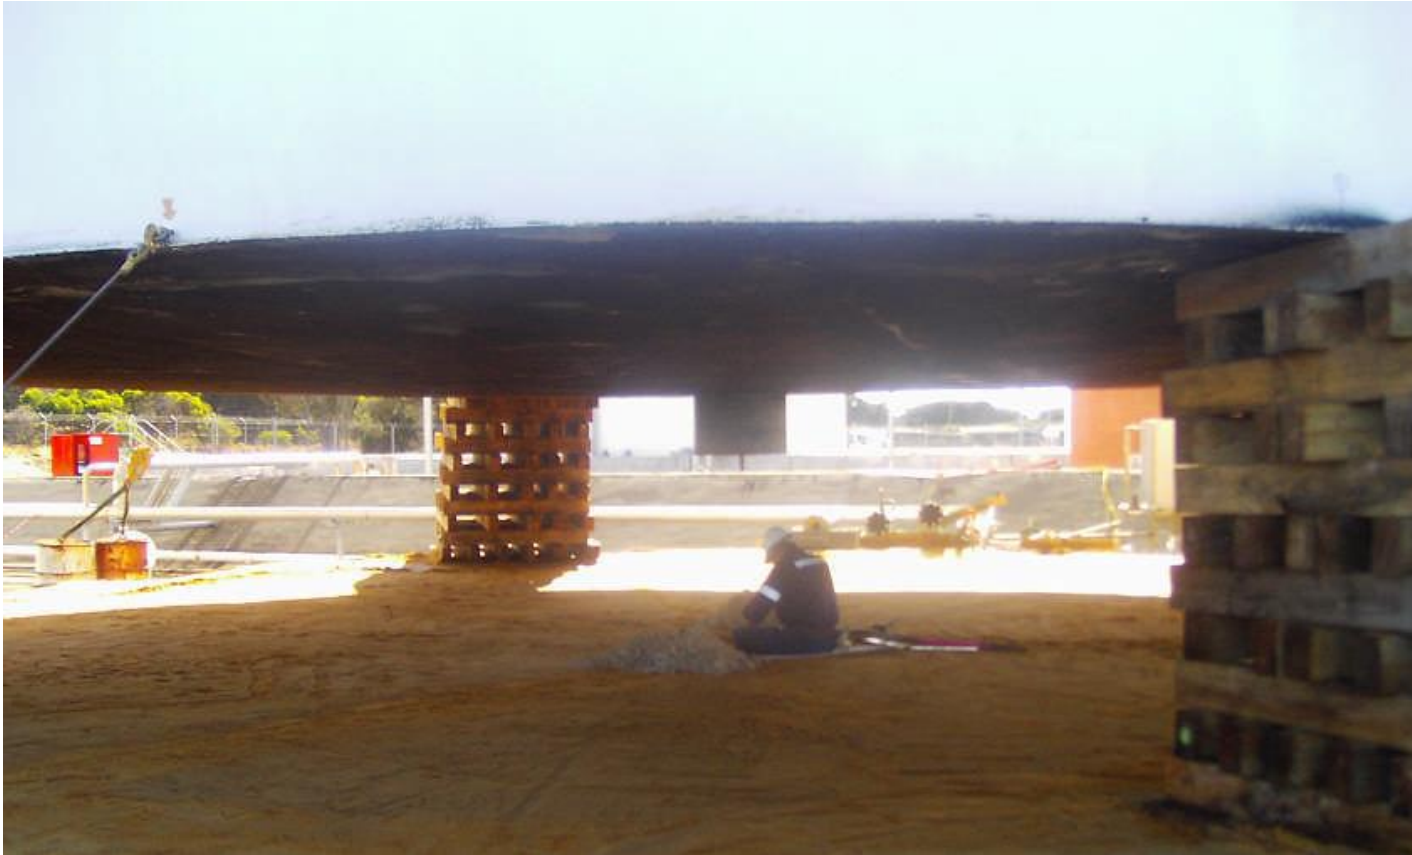
Tank 21 at ALMC had suffered planar tilt outside the limits stated in API 653 Appendix B. The tank was built in 1938 and had leaked through external floor corrosion.

The job was to correct the differential settlement, install a secondary containment liner under the tank and change the floor in the tank.

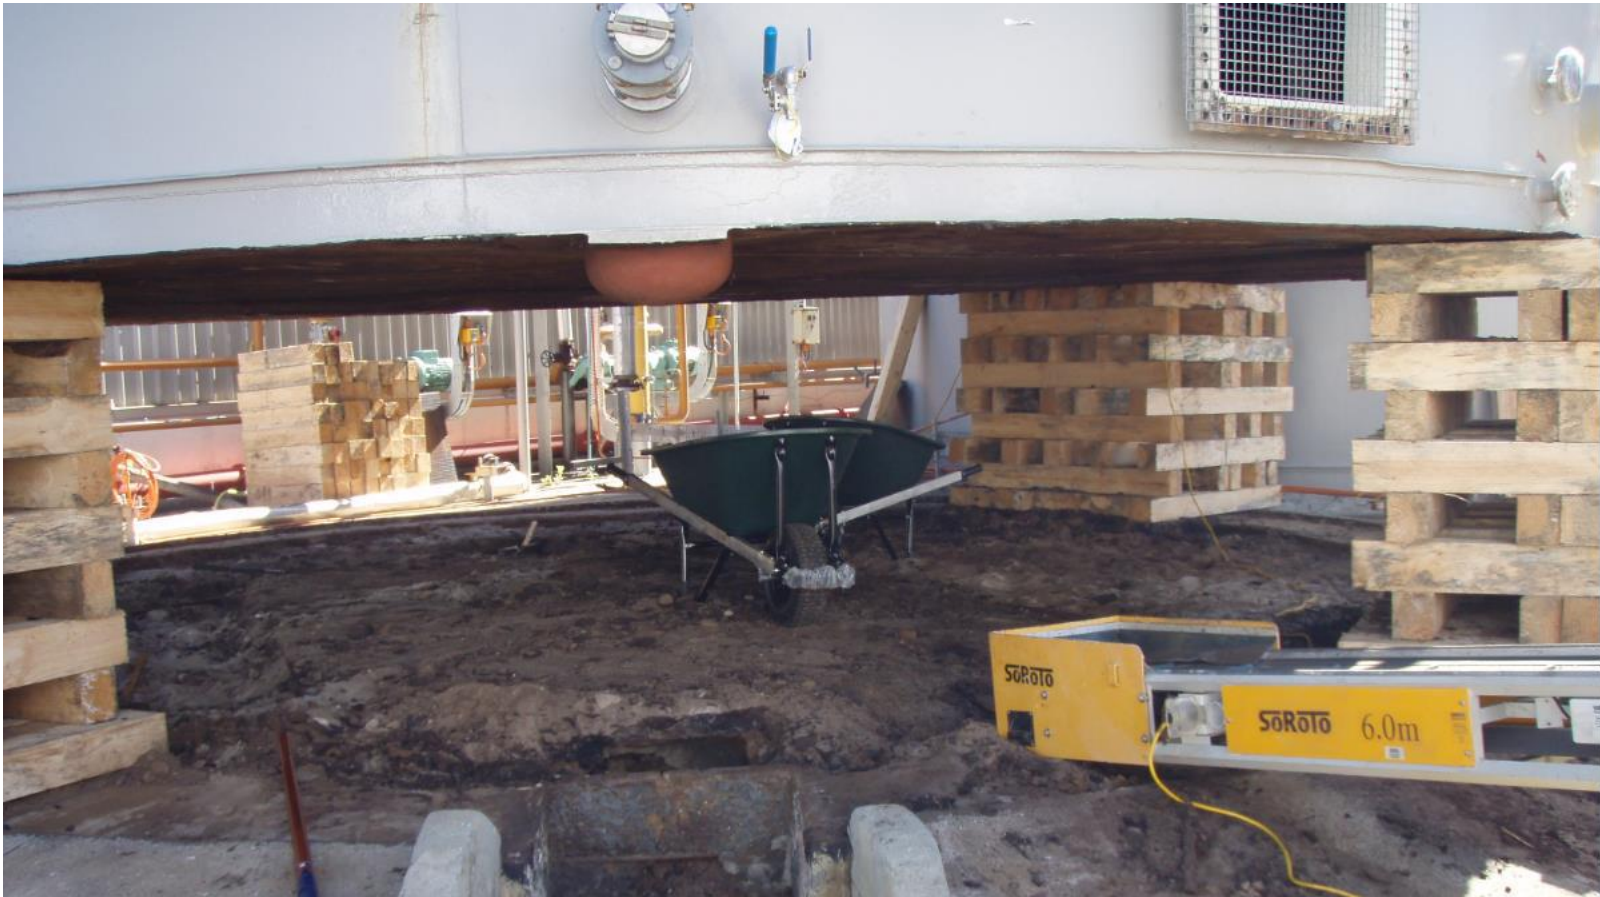
Upon attaining access height under the tank the lifting cribs are removed and the basecourse foundation cap is taken out. This particular tank dihedral of the floor was changed from Cone-Up to 1:120 Cone Down....hence further excavation was required. The concrete ring beam was not level which accounted for the tank differential settlement.
