Ivor Wildin
Director, WTS

API 653: TANK INSPECTION CODE: TANK LIFTING AS AN OPTION TO REPAIR

**FLOOR CHANGE
AUSTRALIAN LUBRICATION MANUFACTURERS
FREMANTLE, WESTERN AUSTRALIA
A JOINT CALTEX/BP FACILITY**

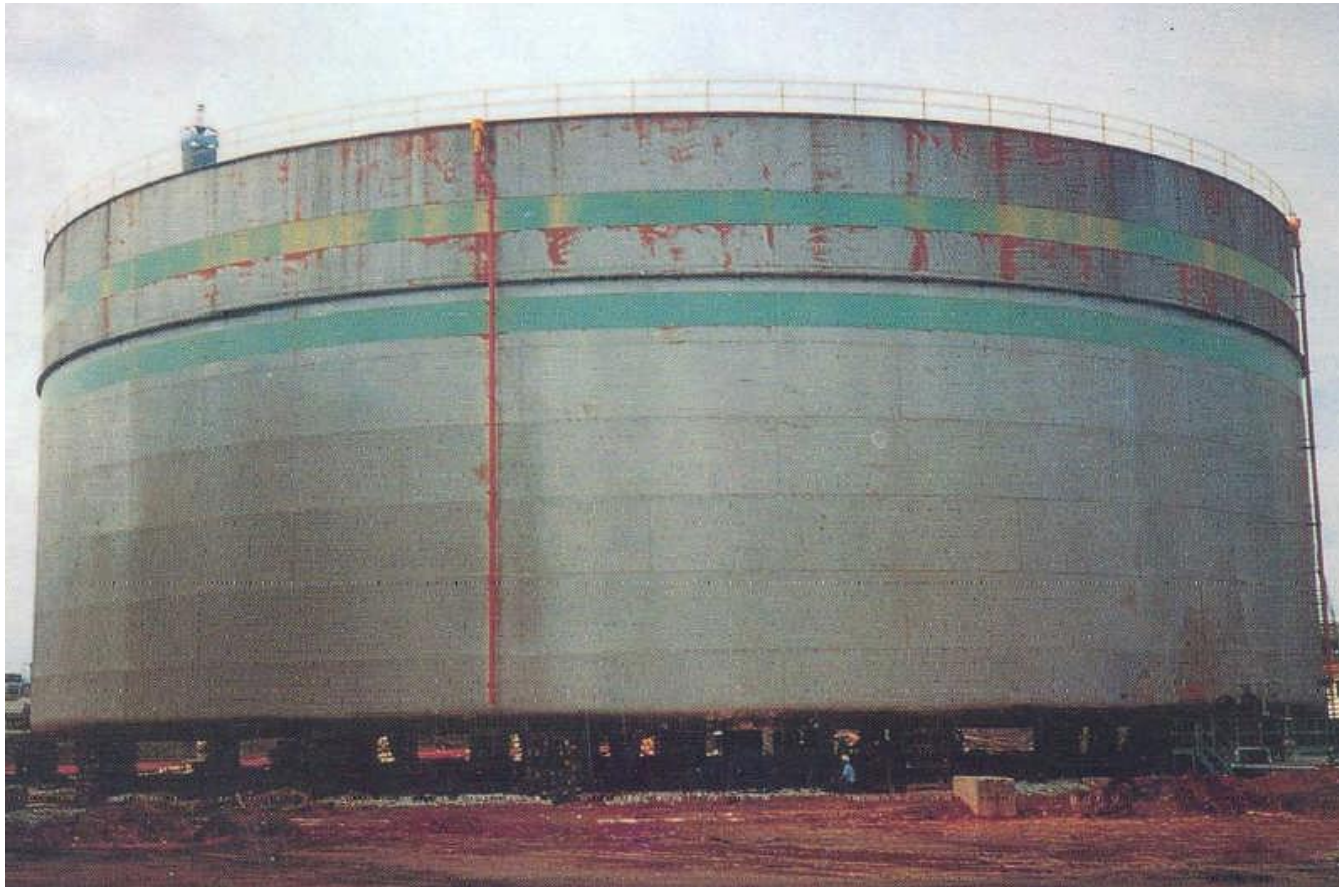
53 X 19M
SRC Singapore

This tank had leaked twice at SRC Singapore and the floor was to be replaced. After lifting it was found that the MFL Scan was in error and there was only two holes in the floor due to stones the rest of the floor had the heat numbers still visible in perfect condition!

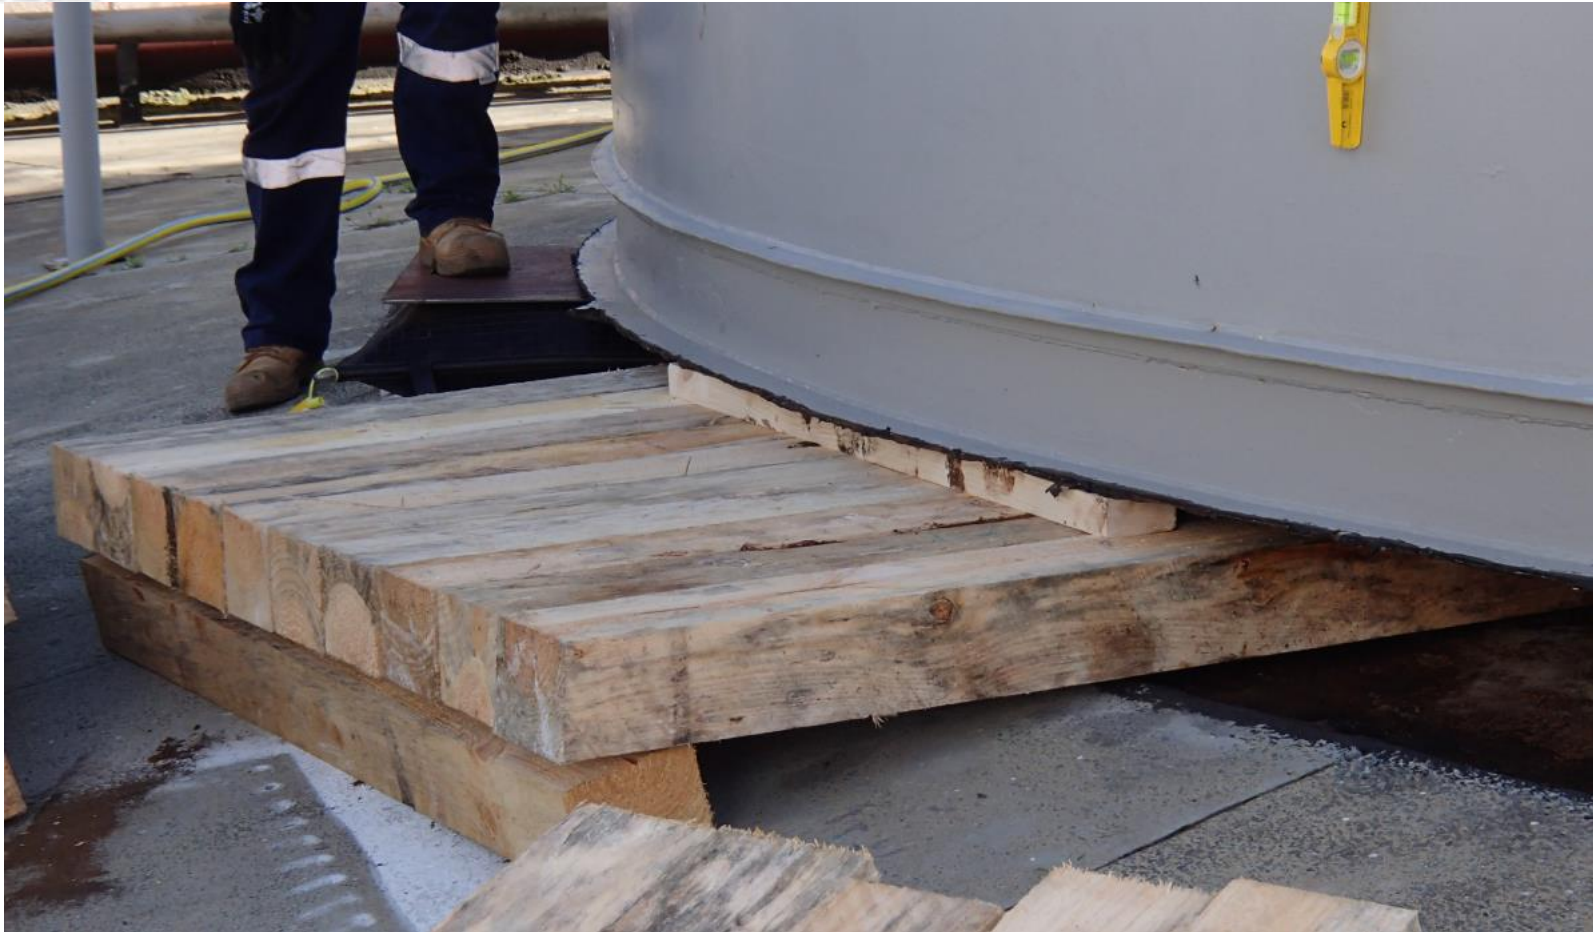
As the tank rises pushed up by the airbags the height gain is consolidated by inserting timber gluts under the tank. The number and support and lifting positions is dictated by a computer program which ensures the stability of the tank and that the compressive loads do not exceed the bottom strake buckling (API 650) of the tank.

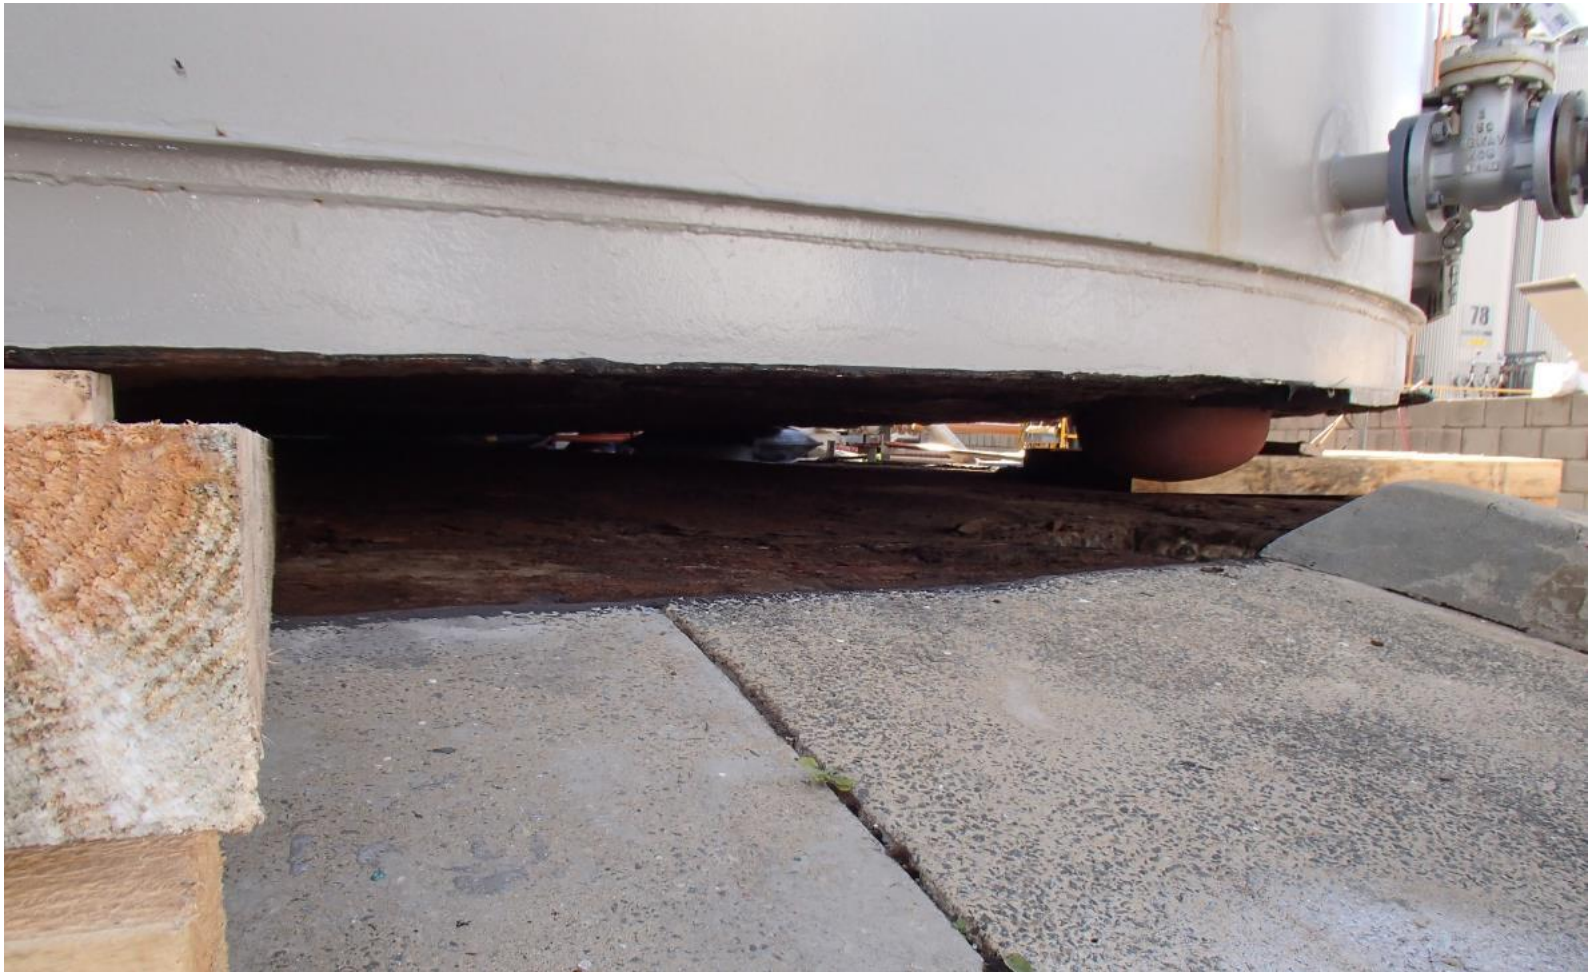
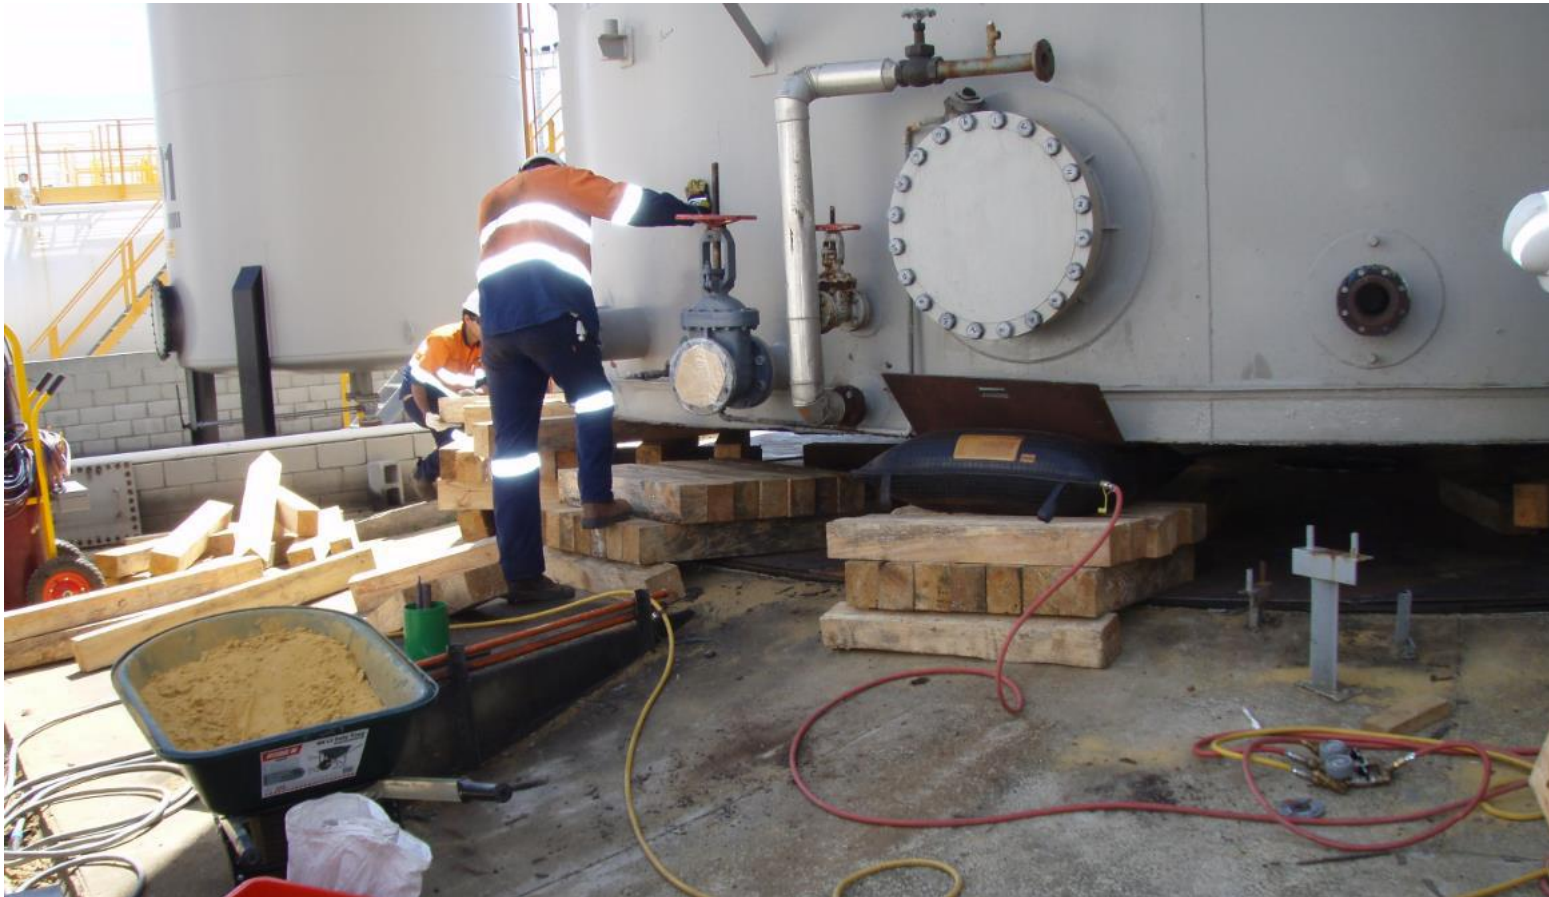
As the tank rises the airbags are placed on cribs of timber which then allows the tank to be lifted increasingly higher. The height gain is constantly consolidated by inserting further timber gluts on the support cribs. The tank always remains LEVEL +/- 6 inches side to side minimising any stresses imposed in the lifting.

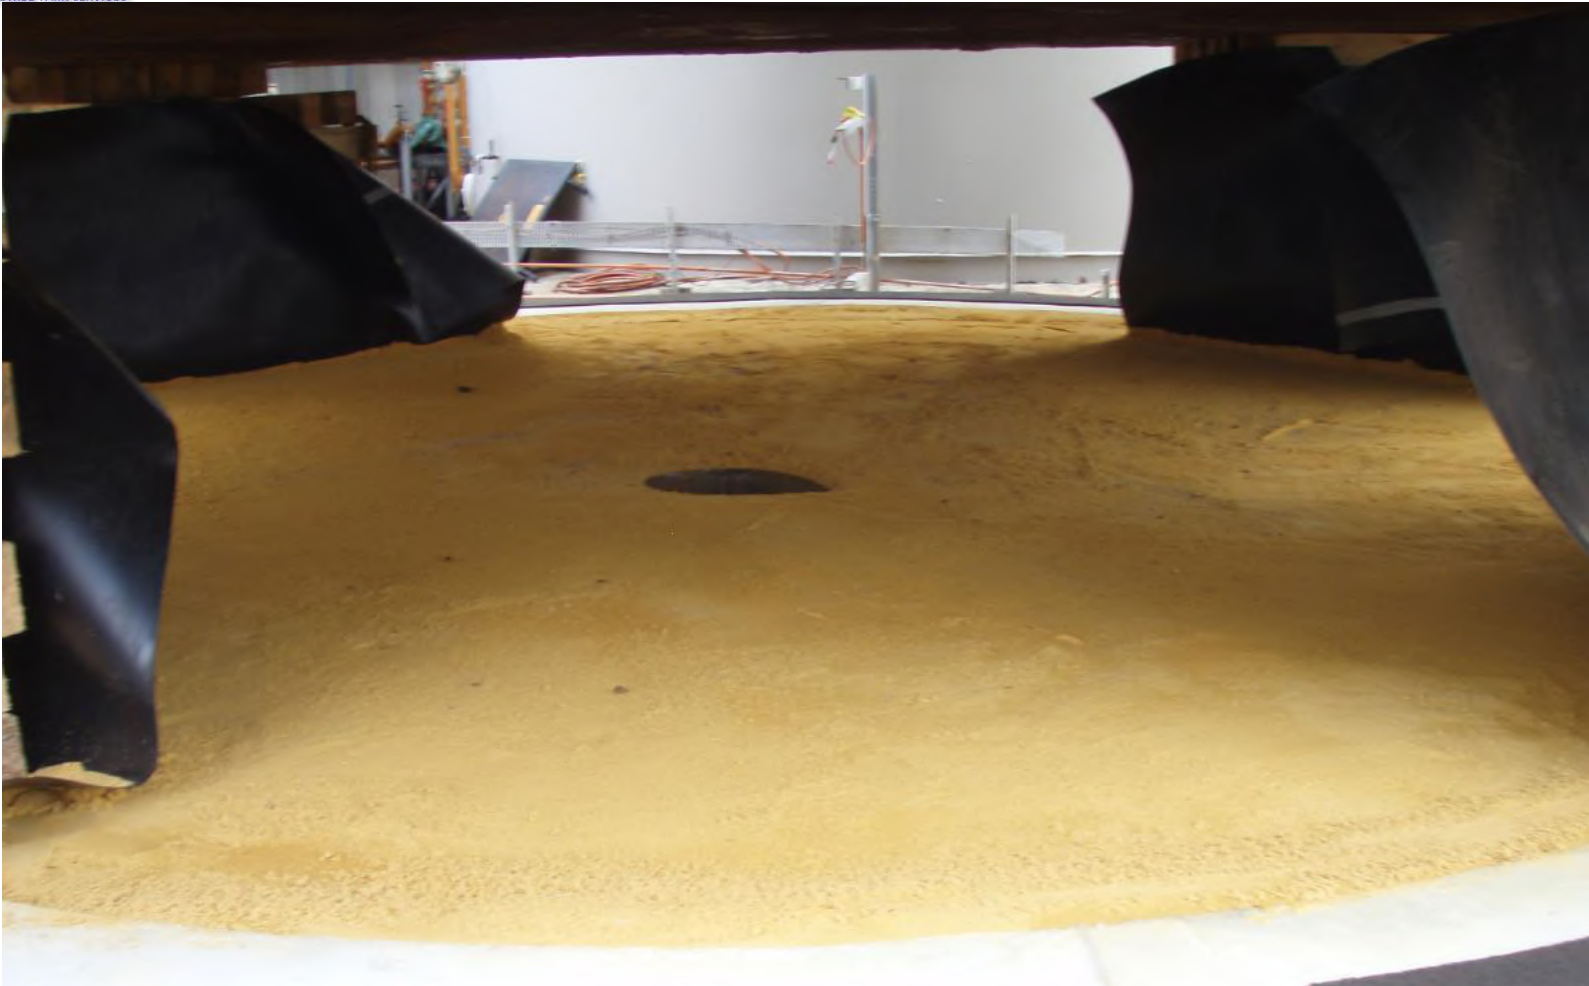
After filling of the basecourse it was now time to place in the secondary containment. A drain pipe was incorporated in the basecourse to allow draining in the event of a release under the tank.

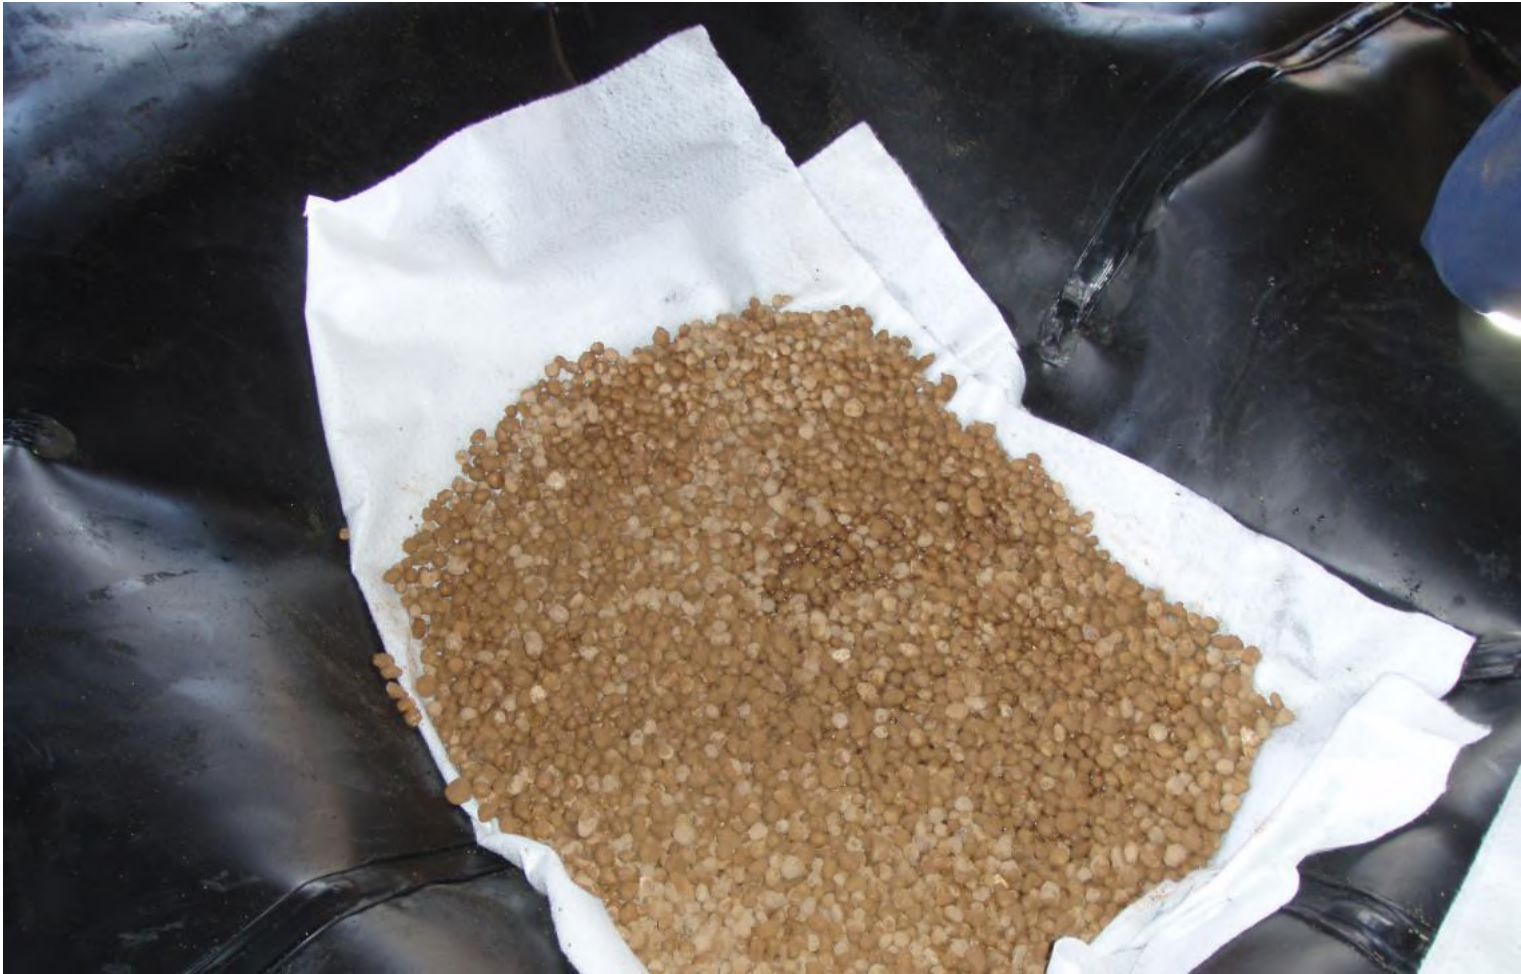
Geotextile and pea gravel is added to ensure free drainage in the secondary containment sump

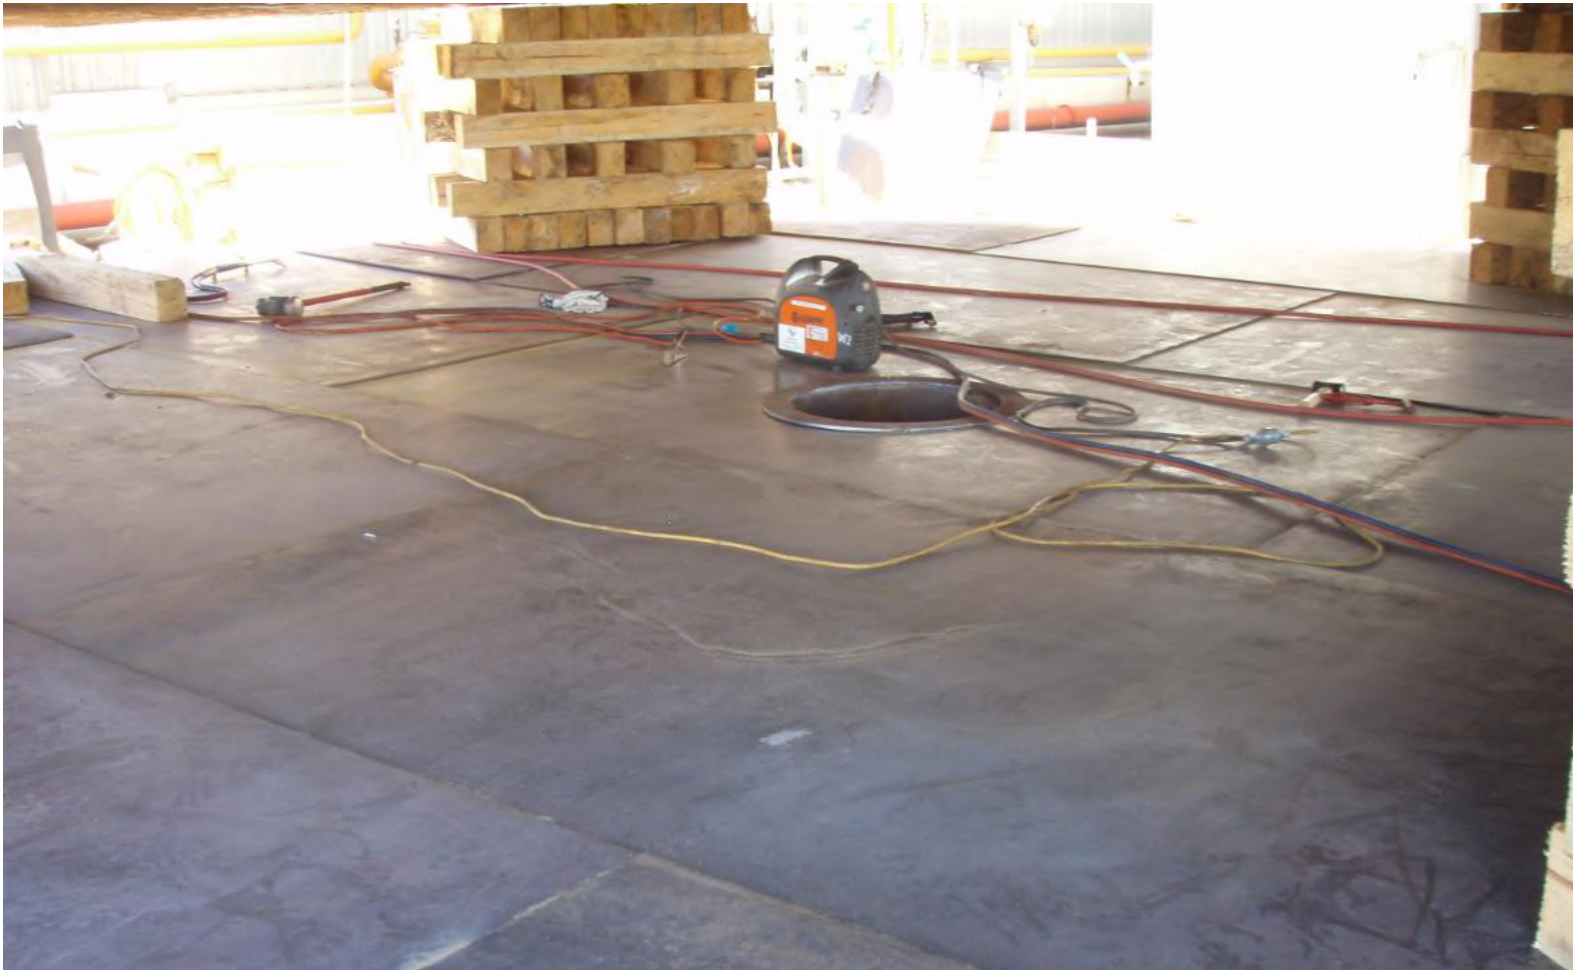
The new sump is added to the floor and welded into place

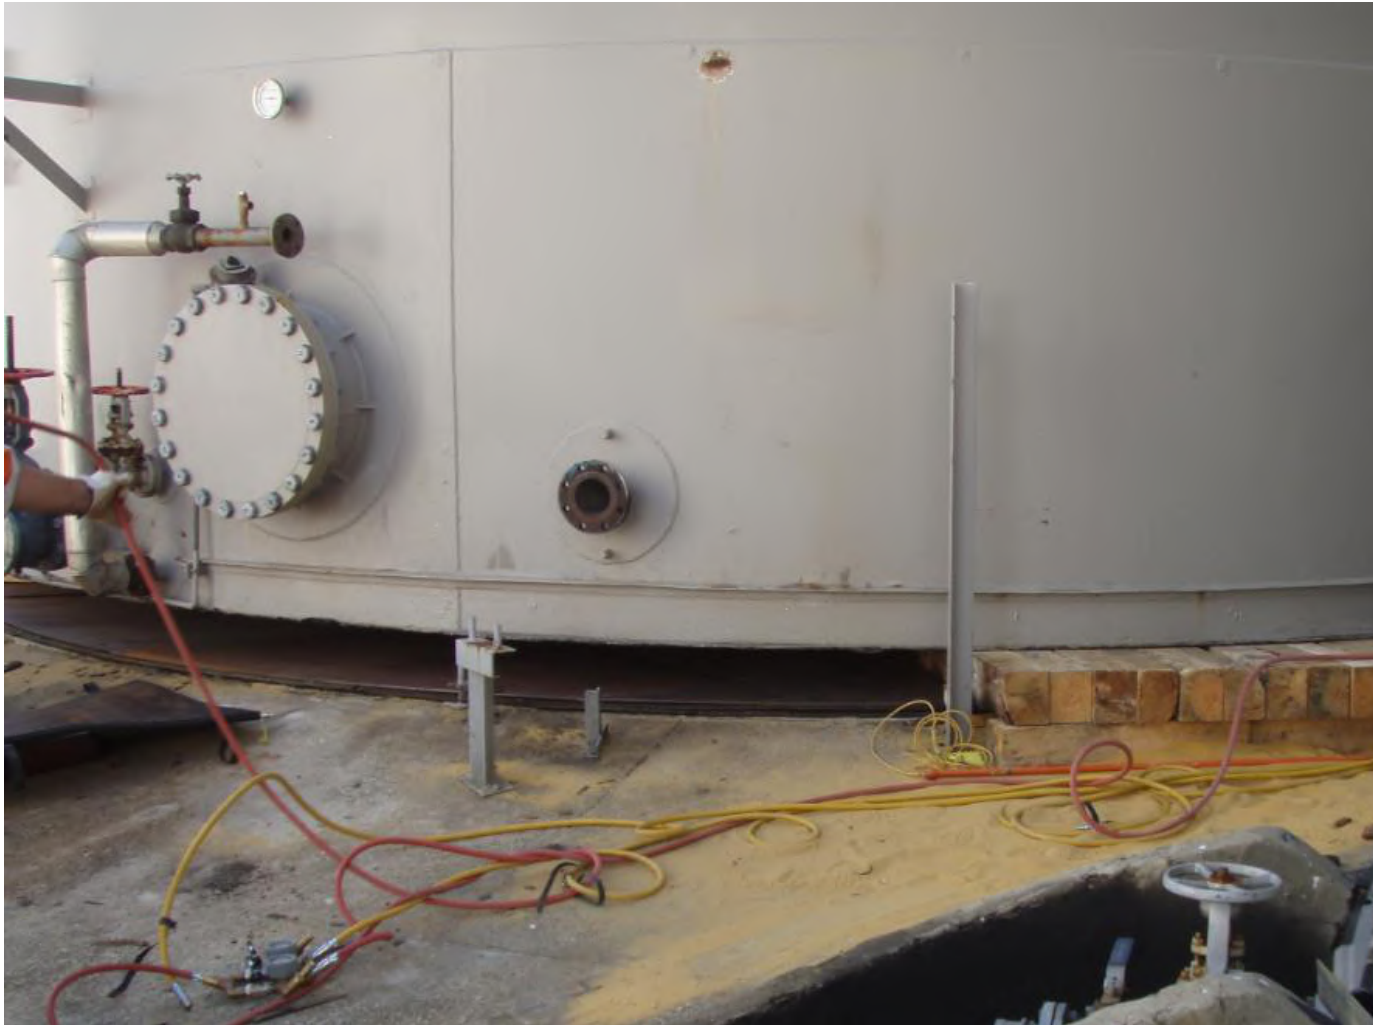
The tank remains at 6 inches above the new floor to allow the cutting out of the old floor

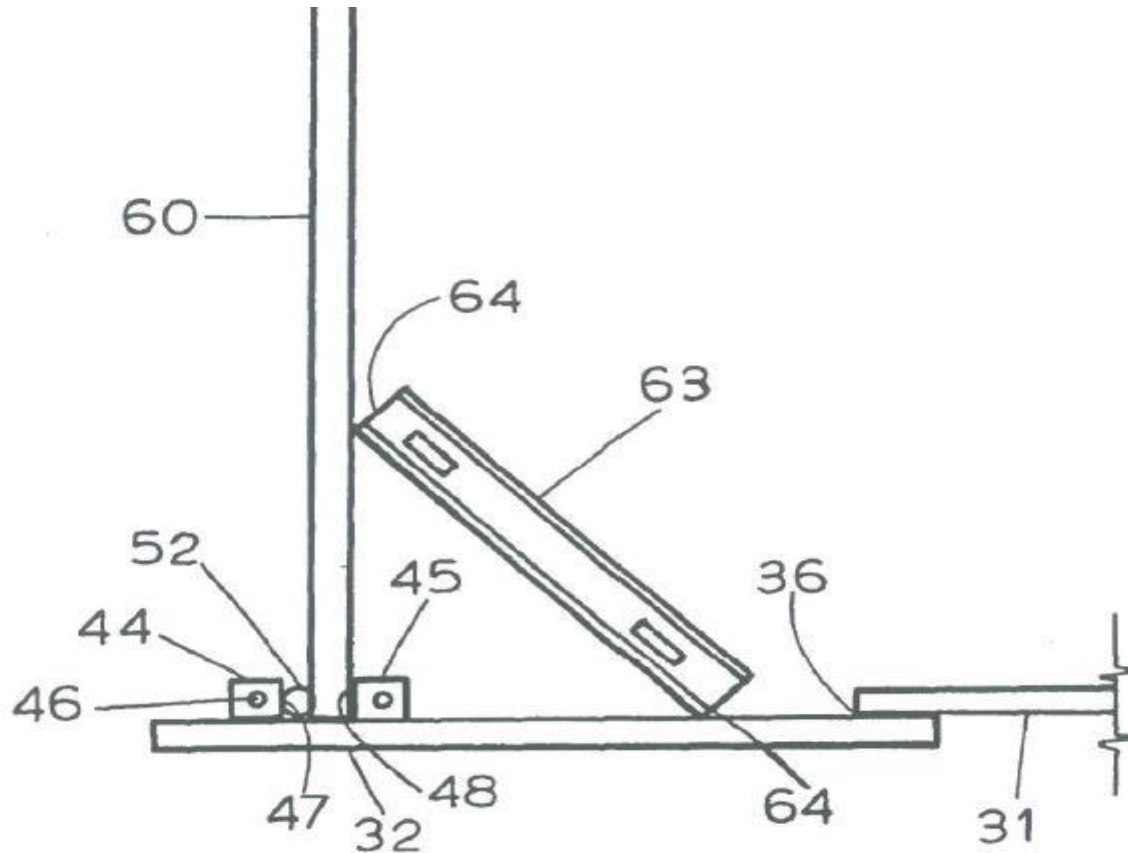
The setting of Blank Nuts (44 - 46) allow us to ensure that the tank wall is on the scribe line and can be adjusted by the insertion of the carrot pins (taper wedges - 52) ensuring the tank remains 'round'.

The tank can now be welded in the normal way and the floor welded internally.
